GLEN BASLER LAKE DAM

STE. GENEVIEVE COUNTY, MISSOURI

MO 31382

PHASE 1 INSPECTION REPORT NATIONAL DAM SAFETY PROGRAM

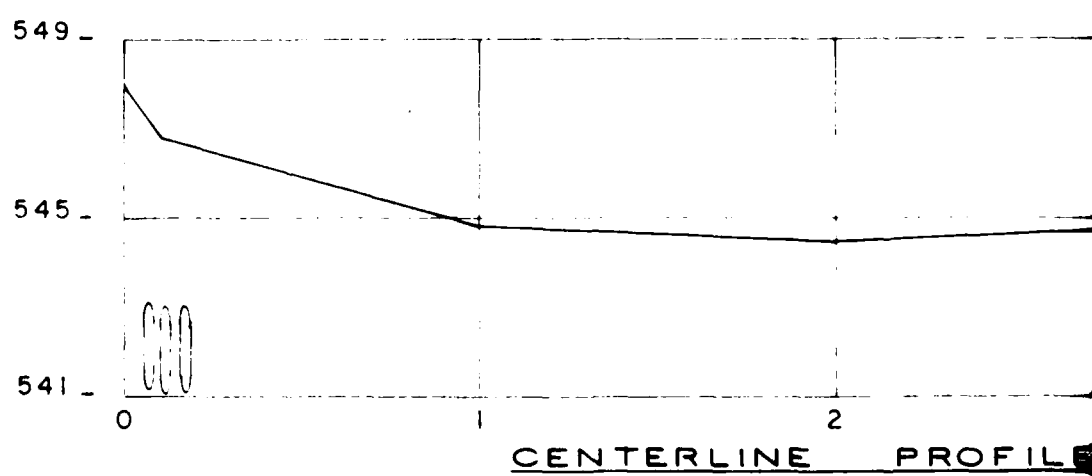
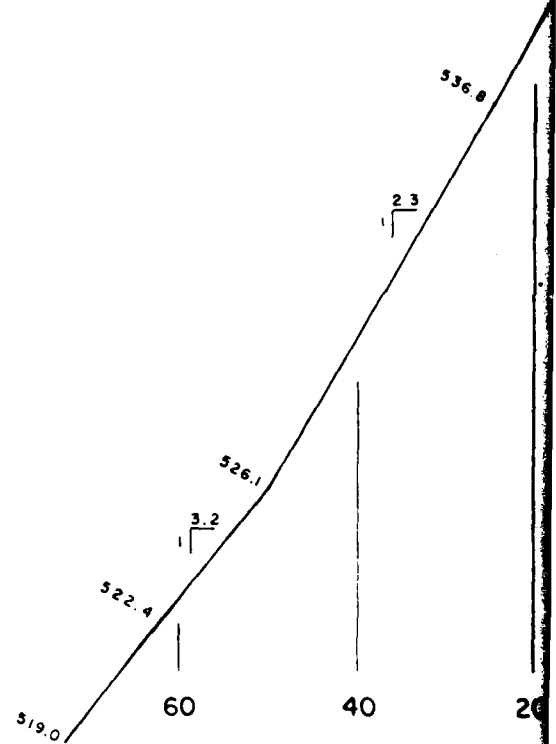
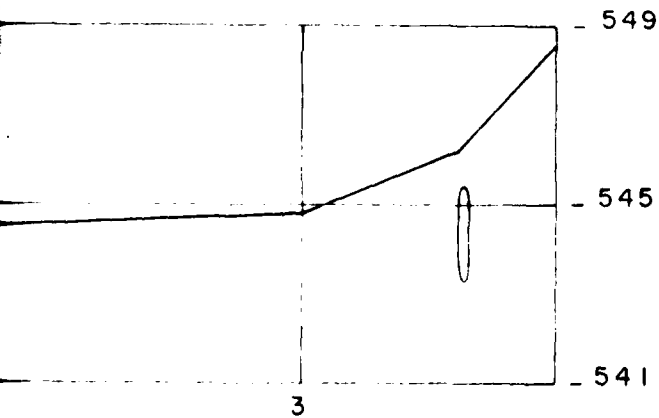
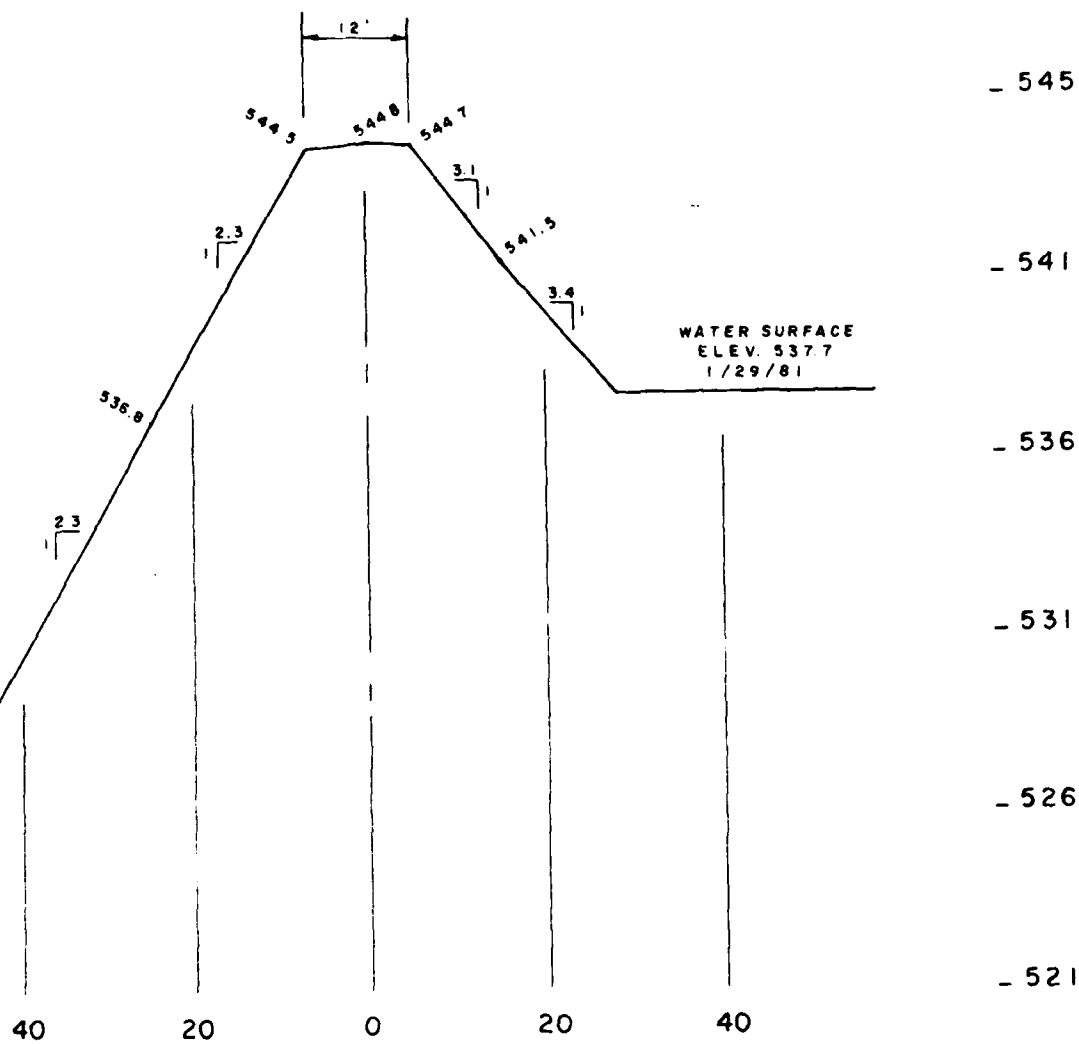
SHEET 3, APPENDIX A

BENCHMARK:
INVERT EAST PIPE STA 0+17
16ft. RIGHT, ELEV. 541.0 M.S.L

EMERGENCY SPILLWAY
PIPE

SECTION

PROFILE

SECTION A-A STA 1+00

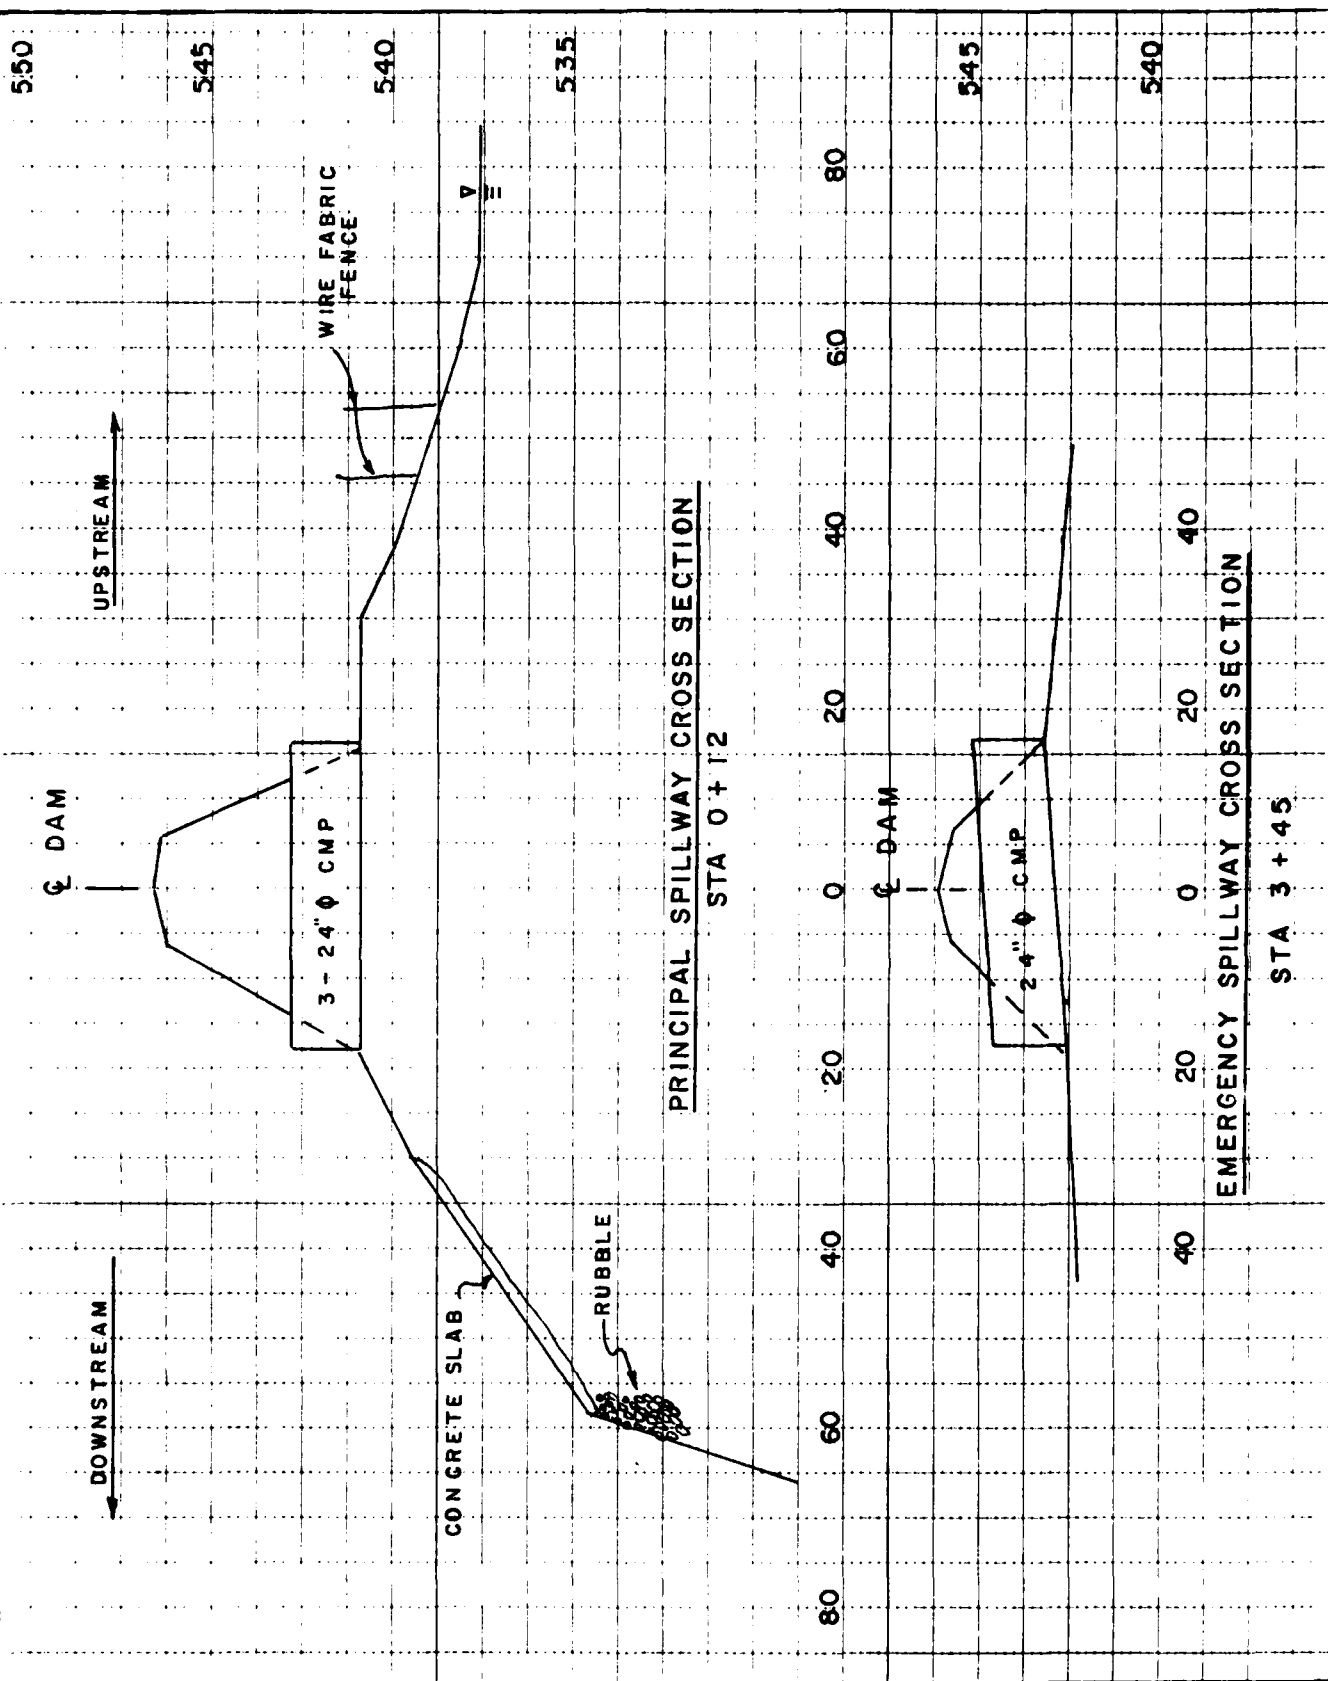
SHEET 4, APPENDIX A

PROFILE & SECTION OF SPILLWAY
GLEN BASLER LAKE DAM
STE. GENEVIEVE COUNTY, MISSOURI
MO. I. D. No. 31382

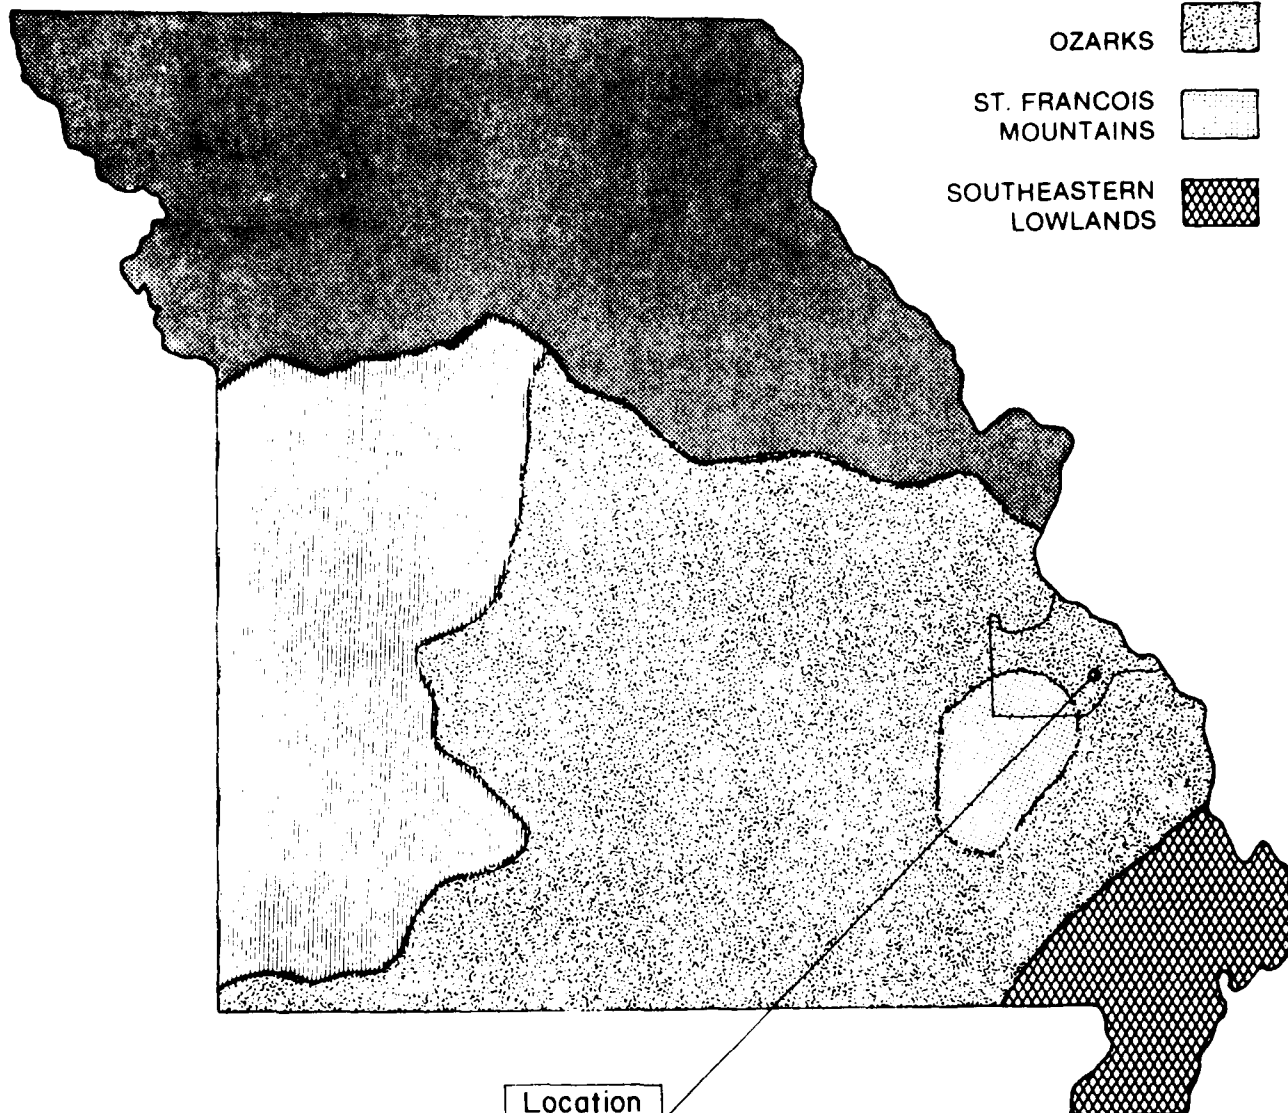
SHEET 1, APPENDIX B

MAJOR GEOLOGIC REGIONS OF MISSOURI

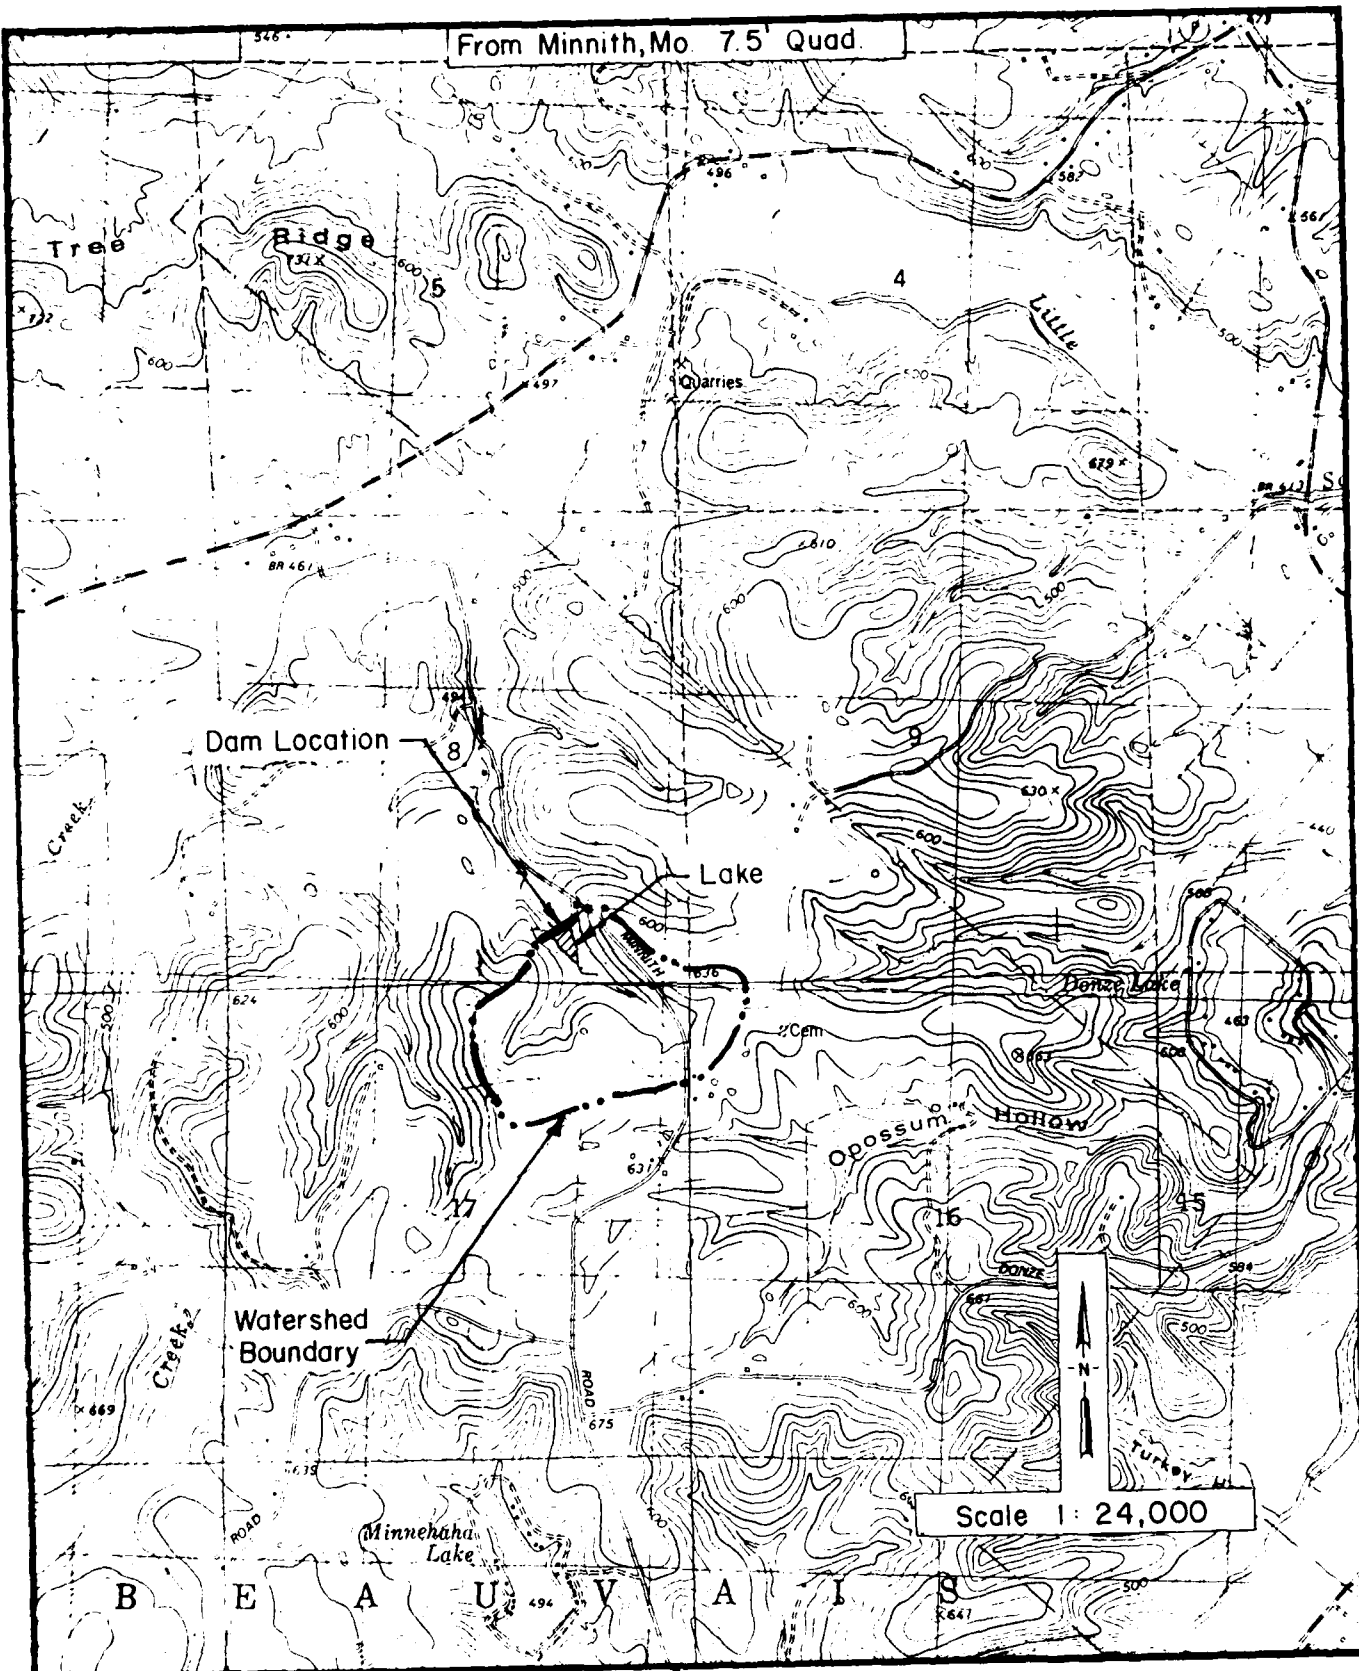
LAKE AND WATERSHED MAP

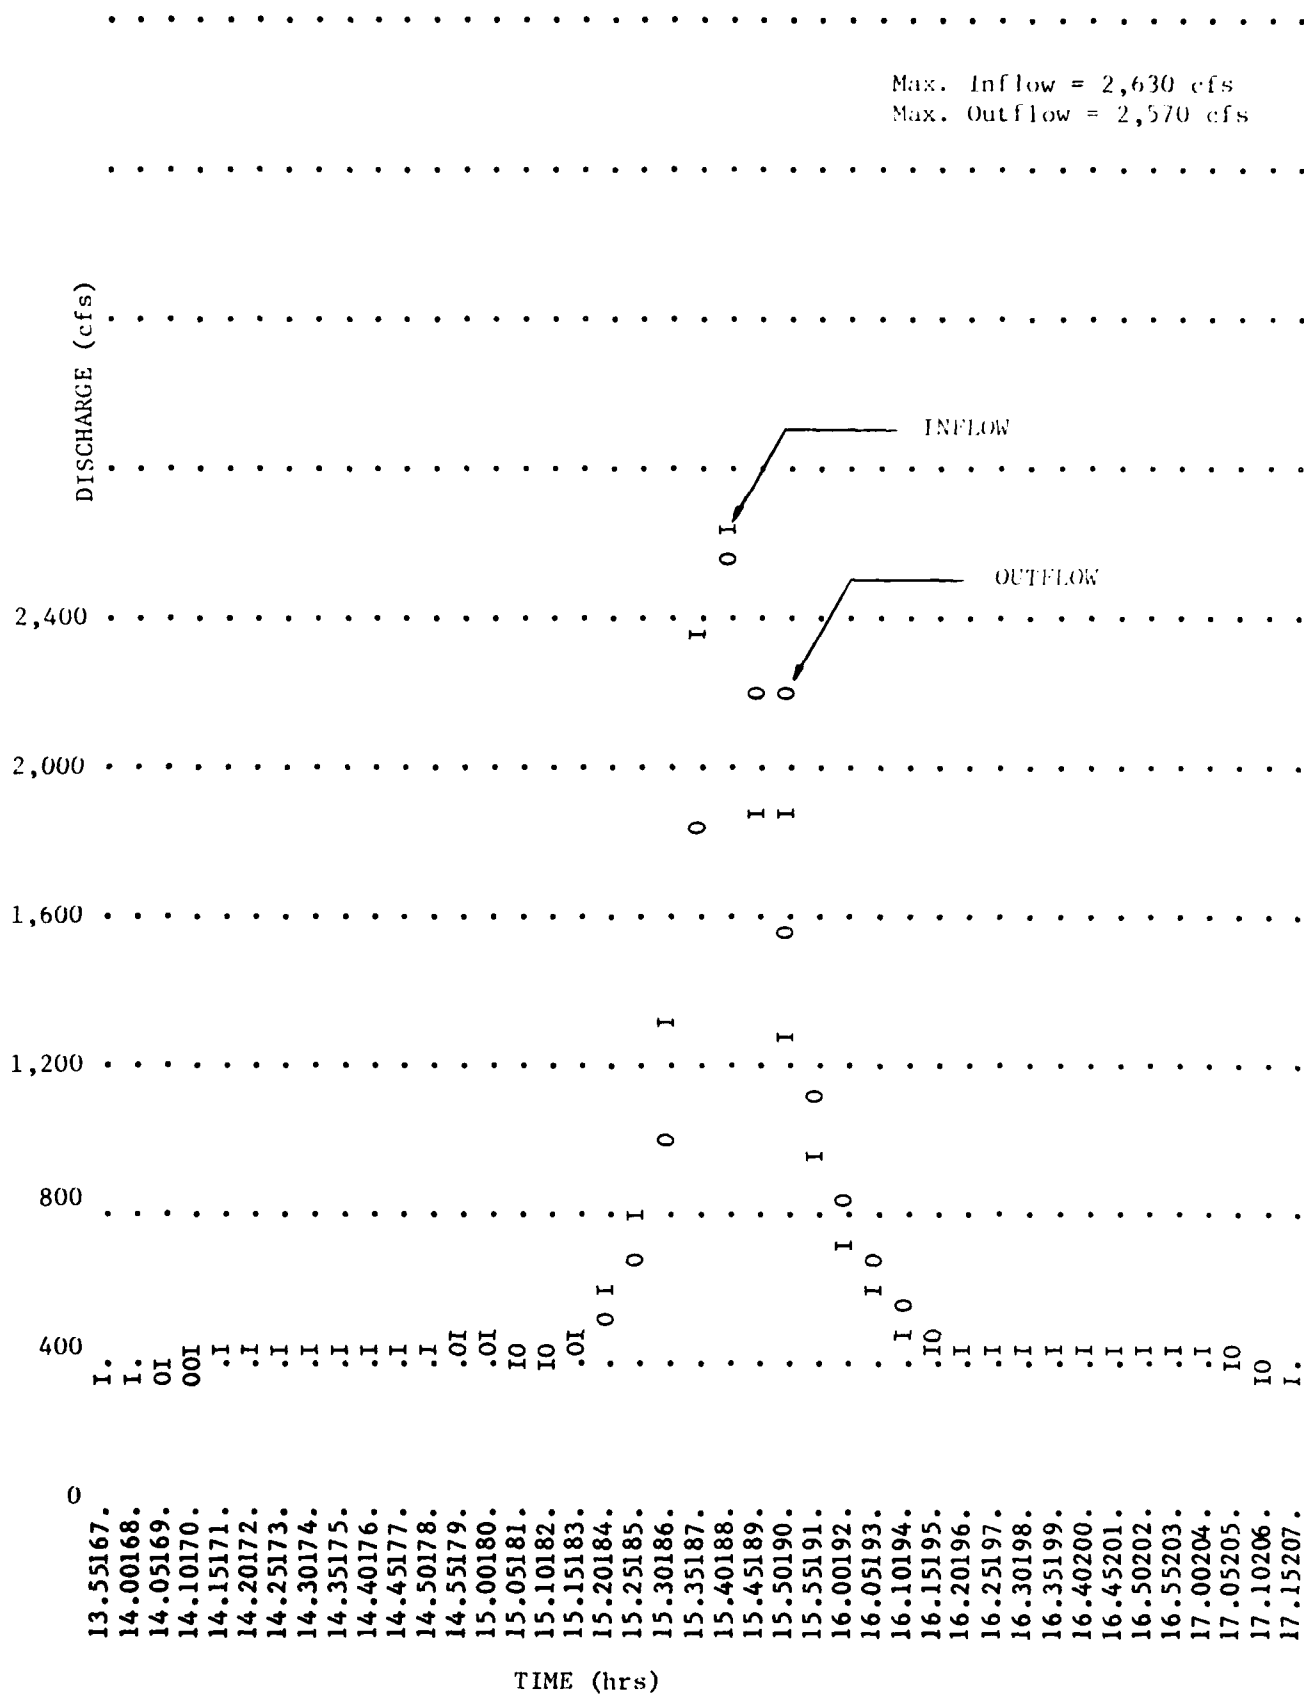
INFLOW-OUTFLOW HYDROGRAPH
FOR THE PMF

PLAN 1		INITIAL VALUE	SPILLWAY CREST	TOP OF DAM				
ELEVATION		541.00	541.00	544.50				
STORAGE		28.	28.	41.				
OUTFLOW		0.	0.	65.				
PMF RATIOS OUTPUT DATA	RATIO OF PMF	MAXIMUM RESERVOIR W.S.ELEV	MAXIMUM DEPTH OVER DAM	MAXIMUM STORAGE AC-FT	MAXIMUM OUTFLOW CFS	DURATION OVER TOP HOURS	TIME OF MAX OUTFLOW HOURS	TIME OF FAILURE HOURS
	0.10	544.42	0.00	41.	63.	0.00	16.08	0.00
	0.15	545.04	0.54	44.	230.	2.00	15.83	0.00
	0.20	545.32	0.82	45.	435.	3.08	15.75	0.00
	0.25	545.46	0.96	46.	559.	4.33	15.75	0.00
	0.30	545.58	1.08	47.	683.	5.08	15.67	0.00
	0.40	545.81	1.31	48.	947.	6.08	15.67	0.00
	0.50	546.01	1.51	49.	1214.	6.75	15.67	0.00
	0.75	546.44	1.94	51.	1886.	7.83	15.67	0.00
	1.00	546.81	2.31	53.	2565.	10.17	15.67	0.00

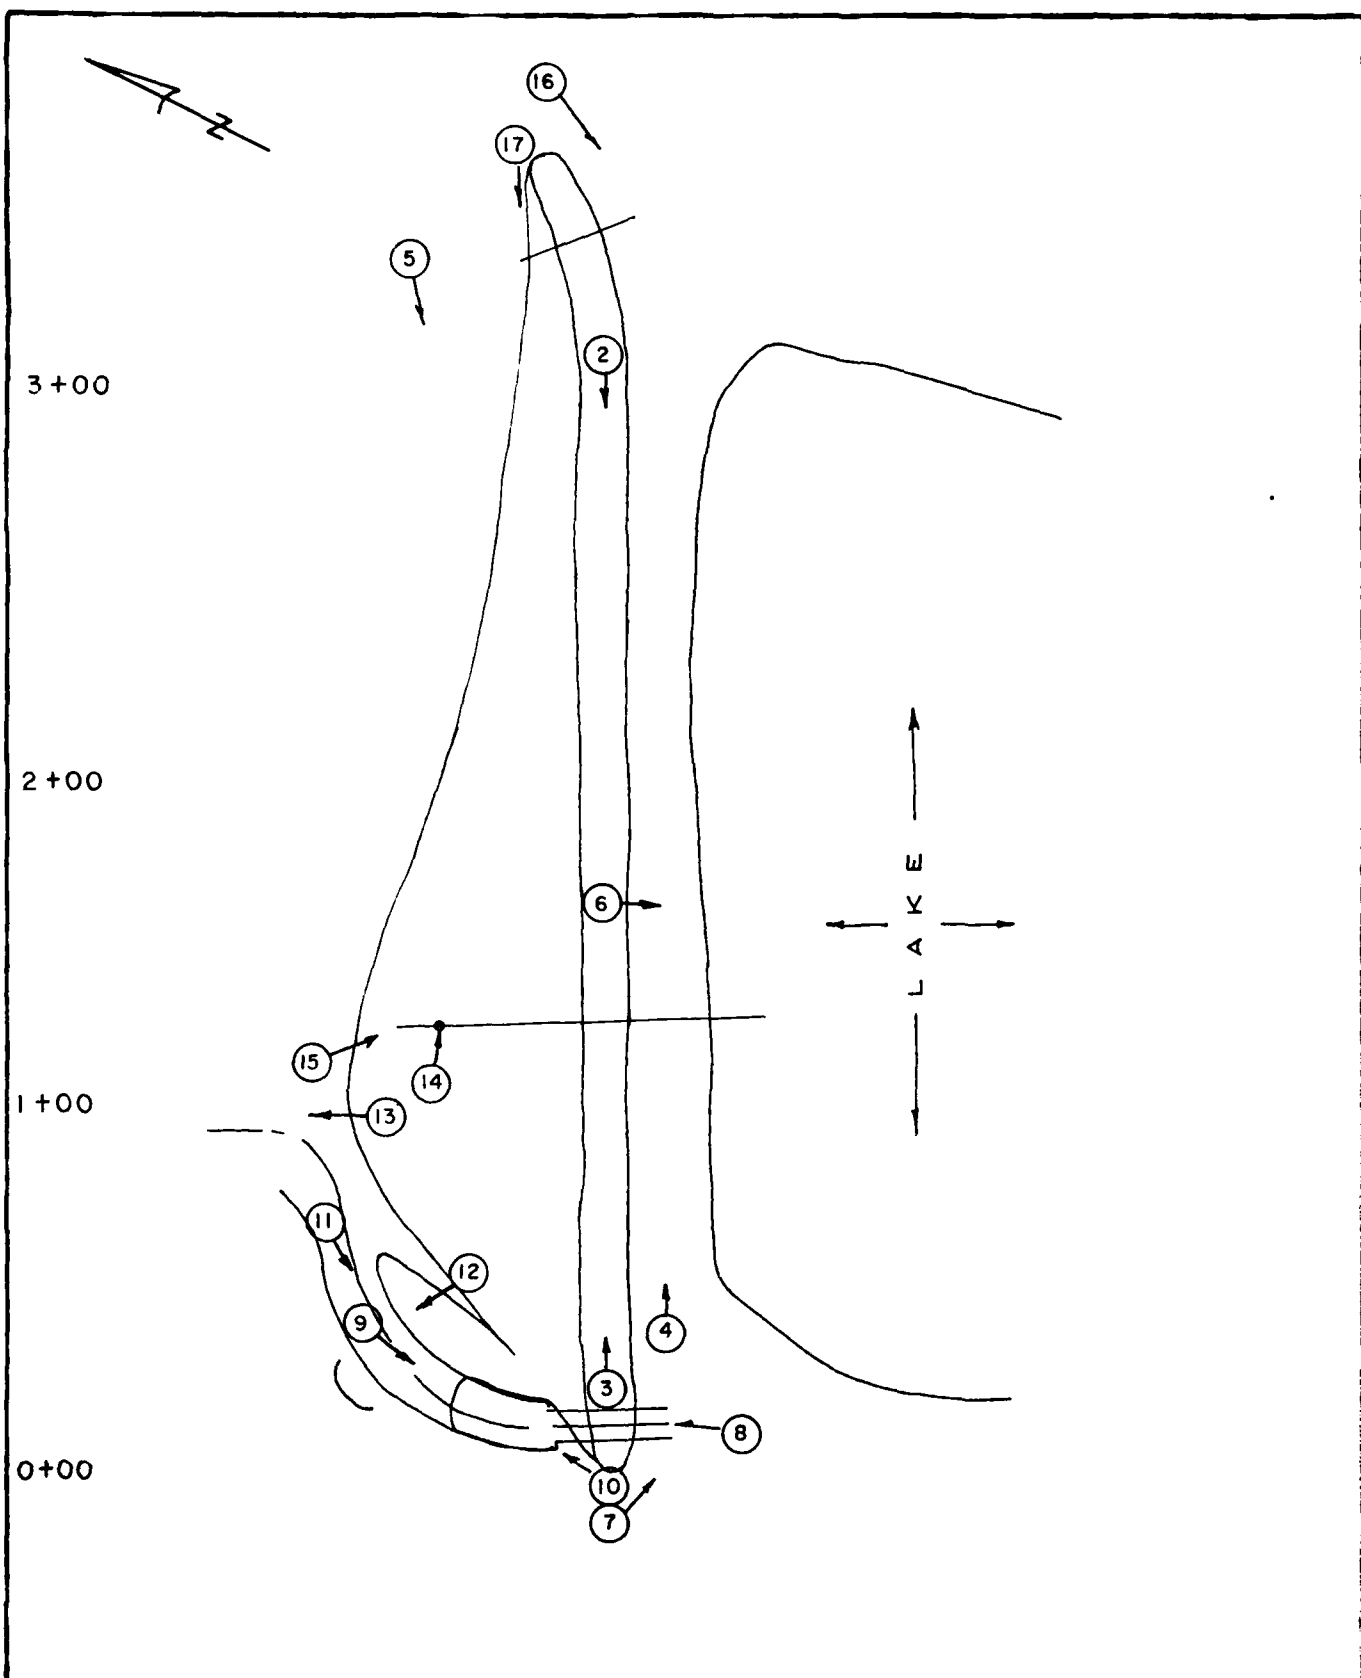
SHEET 2 , APPENDIX D

PHOTOGRAPHIC INDEX

<u>Photo No.</u>	<u>Description</u>
1	Aerial (looking South)
2	Crest of Dam (looking West)
3	Crest of Dam (looking East)
4	Upstream Face of Dam (looking East)
5	Downstream Face of Dam (looking Southwest)
6	Reservoir Watershed (looking Southeast)
7	Principal Spillway Inlet Area
8	Principal Spillway Inlet Area
9	Undermining of Principal Spillway Concrete Slab
10	Principal Spillway Outlet Channel
11	End of Principal Spillway Outlet Channel
12	Slough in Outlet Channel Wall
13	Downstream Channel
14	Watering Pipe Valve
15	Discharge End of Watering Pipe
16	Emergency Spillway Inlet Area
17	Emergency Spillway Outlet Area
18	Downstream Hazard Feature
19	Downstream Hazard Feature
20	Downstream Hazard Feature
